Marine Safety Information Bulletin

MSIB Number: 30-18
Date: August 17, 2018
Contact: Waterways Management
Phone: (215) 271-4864
E-Mail: SecDelBayWWM@uscg.mil

Safety Alert 13-18

Potential interference of VHF-FM Radio and AIS Reception.

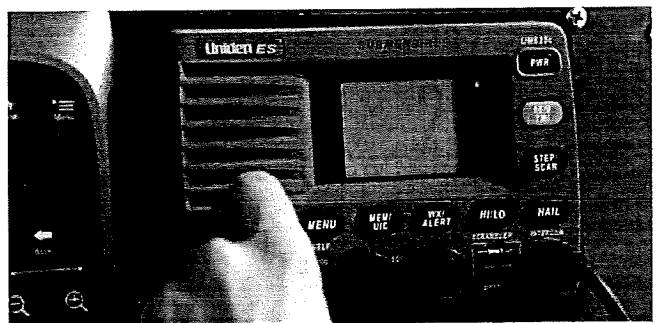
1. Turn off LED light(s).
2. Tune the VHF radio to a quiet channel (e.g. Ch. 13).
3. Adjust the VHF radio's squelch control until the radio outputs audio noise.
4. Re-adjust the VHF radio's squelch control until the audio noise is quiet, only slightly above the noise threshold.

5. Turn on the LED light(s).
 - If the radio now outputs audio noise, then the LED lights have raised the noise floor. (Noise floor is generally the amount of interfering signals / static received beyond the specific signal or channel being monitored.)
6. If the radio does not output audio noise, then the LED lights have not raised the noise floor.

If the noise floor is found to have been raised, then it is likely that both shipboard VHF marine radio and AIS reception are being degraded by LED lighting.
